11. TITLE (Include Security Classification) Rehabilitation of Navigation Lock Walls: Case Histories					
12. PERSONAL AUTHOR(S) McDonald, James E.					
13a. TYPE OF REPORT Final Report	13b. TIME COVERED FROM TO	14. DATE OF REPORT (Year, Month, Day) December 1987		15. PAGE COUNT 316

means for removing large quantities of concrete. Once the deteriorated concrete has been removed, conventional cast-in-place concrete has been used as the replacement material in most lock wall rehabilitation projects. Other replacement systems that have been used or proposed include shotcrete, preplaced-aggregate concrete, and precast concrete stay-in-place forms. In addition, several materials including latex-modified concrete, polymer mortars and grouts, conventional shotcrete, and latex-modified, fiber-reinforced shotcrete have been used as thin overlays on existing lock walls. Applications of the various rehabilitation systems and their performance to date are described in selected case histories.

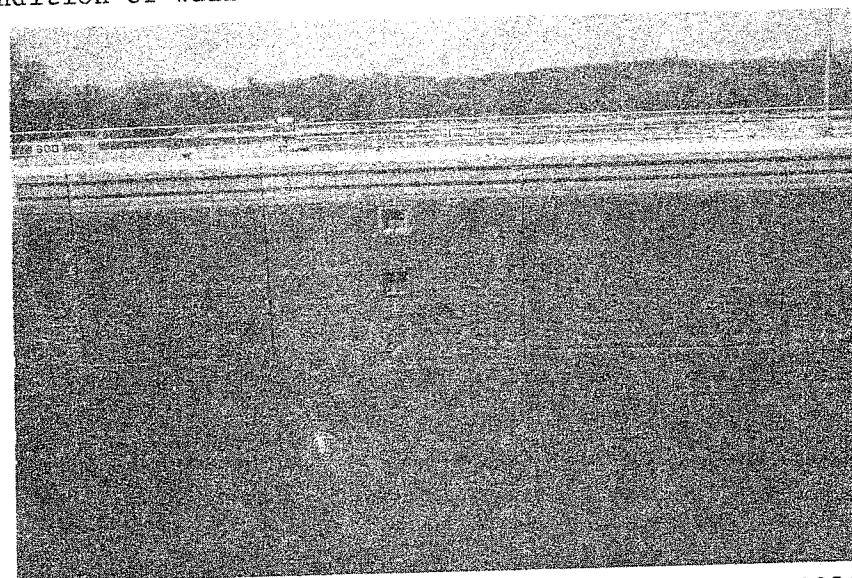
85. Shrinkage cracks in the replacement concrete were observed during the resurfacing operation. The cracks were about 4 to 8 ft apart and generally ran in both horizontal and vertical directions. Since such cracking may accelerate concrete disintegration, the cracks were considered undesirable. It was suggested that fiber-reinforced concrete or shrinkage compensating cement might be beneficial in eliminating such cracking (Juzenas 1979).

Figure 42. Condition of replacement concrete, 1986  
Dresden Island Lock

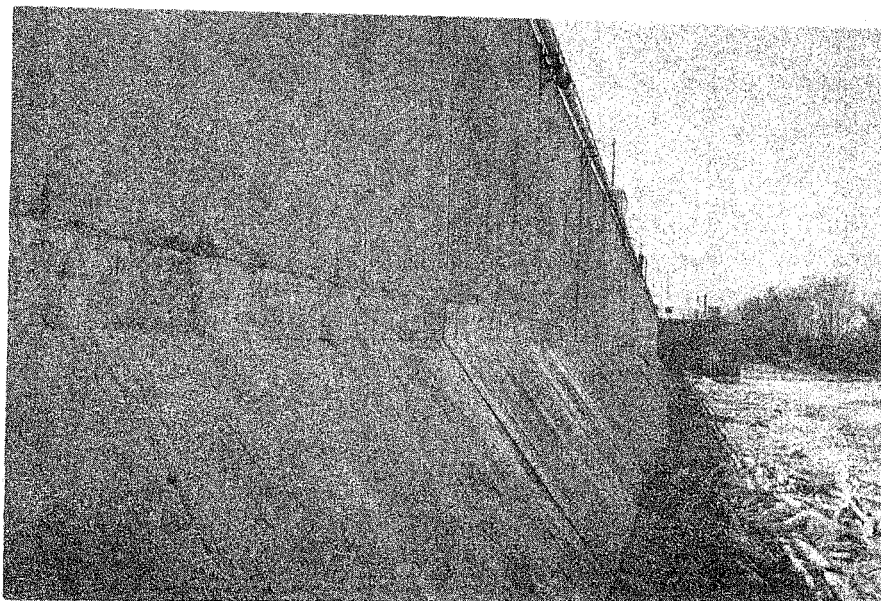
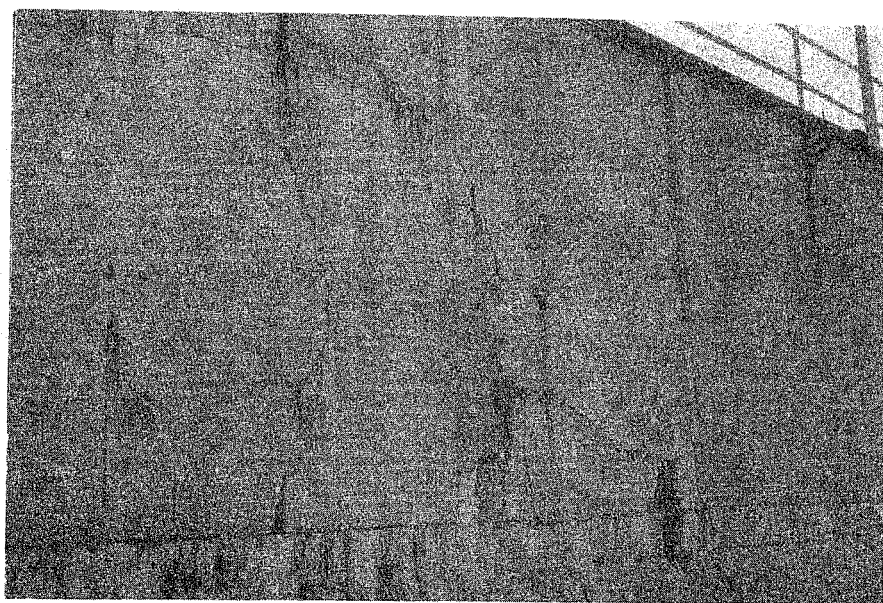
86. Although there is some minor spalling at monolith joints and at the interface between the shotcrete and the concrete placed in 1978 when horizontal armor was installed (Figure 41), overall the shotcrete remains in excellent condition after more than 30 years in service. With the exception of some isolated spalling (Figure 42), the concrete resurfacing inside the lock chamber is in good condition. Cracking previously reported in the replacement concrete has generally been obliterated by staining on the concrete surface. The concrete overlay on the back side of the river wall appears to be in generally good condition although there are a number of cracks in some areas (Figure 43). Minor seepage occurs sporadically through a horizontal cold joint located at midheight on the wall.

Figure 43. Typical condition of concrete overlay on back side of river wall, 1986, Dresden Island Lock

83. The 12-in. thick concrete overlay on the backside of the river wall was placed over the existing weathered concrete (Figure 38). The new concrete was intended to serve as a sealer and to protect the concrete below from further disintegration. The existing weathered concrete was not removed for reasons of economy. It was believed that with anchored concrete, where structural and user considerations permit, this method may be the optimum repair

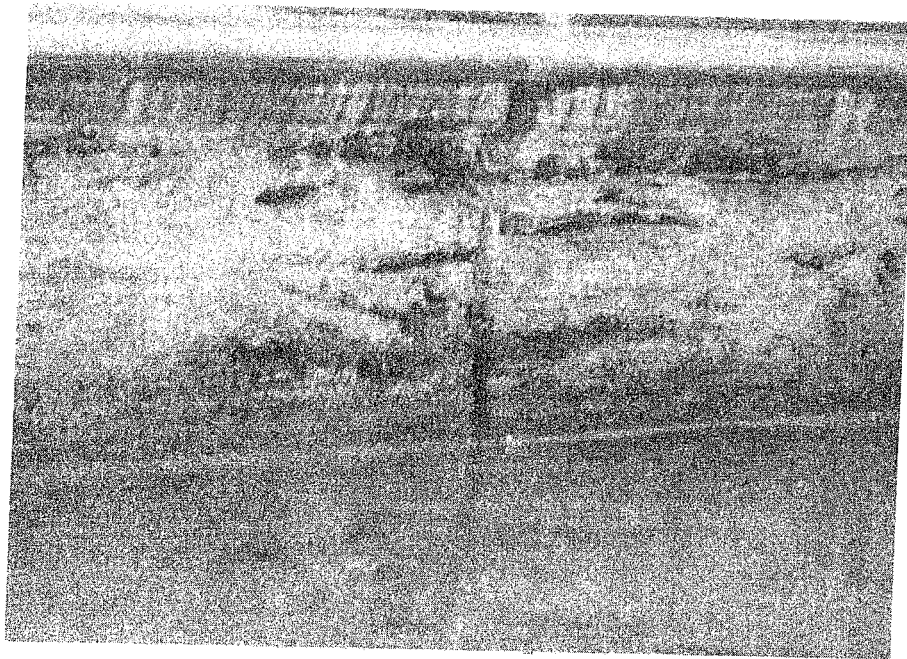
104. The upper guide wall was constructed during the period 1905-1907 and extended in 1926. Severe scouring and gouging had occurred at areas where tows had hit the wall in lining up for lock entry. Wall faces had been scoured back an average of 6 to 8 in. Maximum gouge depth in one reach of the wall was 36 in. (Figure 49). Wall thickness in the area of the gouging is 4 ft from the top of the wall to elevation 731.83 and 5 ft 2 in. between elevations 731.83 and 728.17. Continued scouring and gouging could have resulted in failure of the guide wall. One section from Station 4+25A to Station 6+52A was designated as extremely critical, and the repairs were started by District hired-labor forces in August 1976.

Figure 49. Upper guide wall deterioration, 1974,  
Lock No. 3, Monongahela River

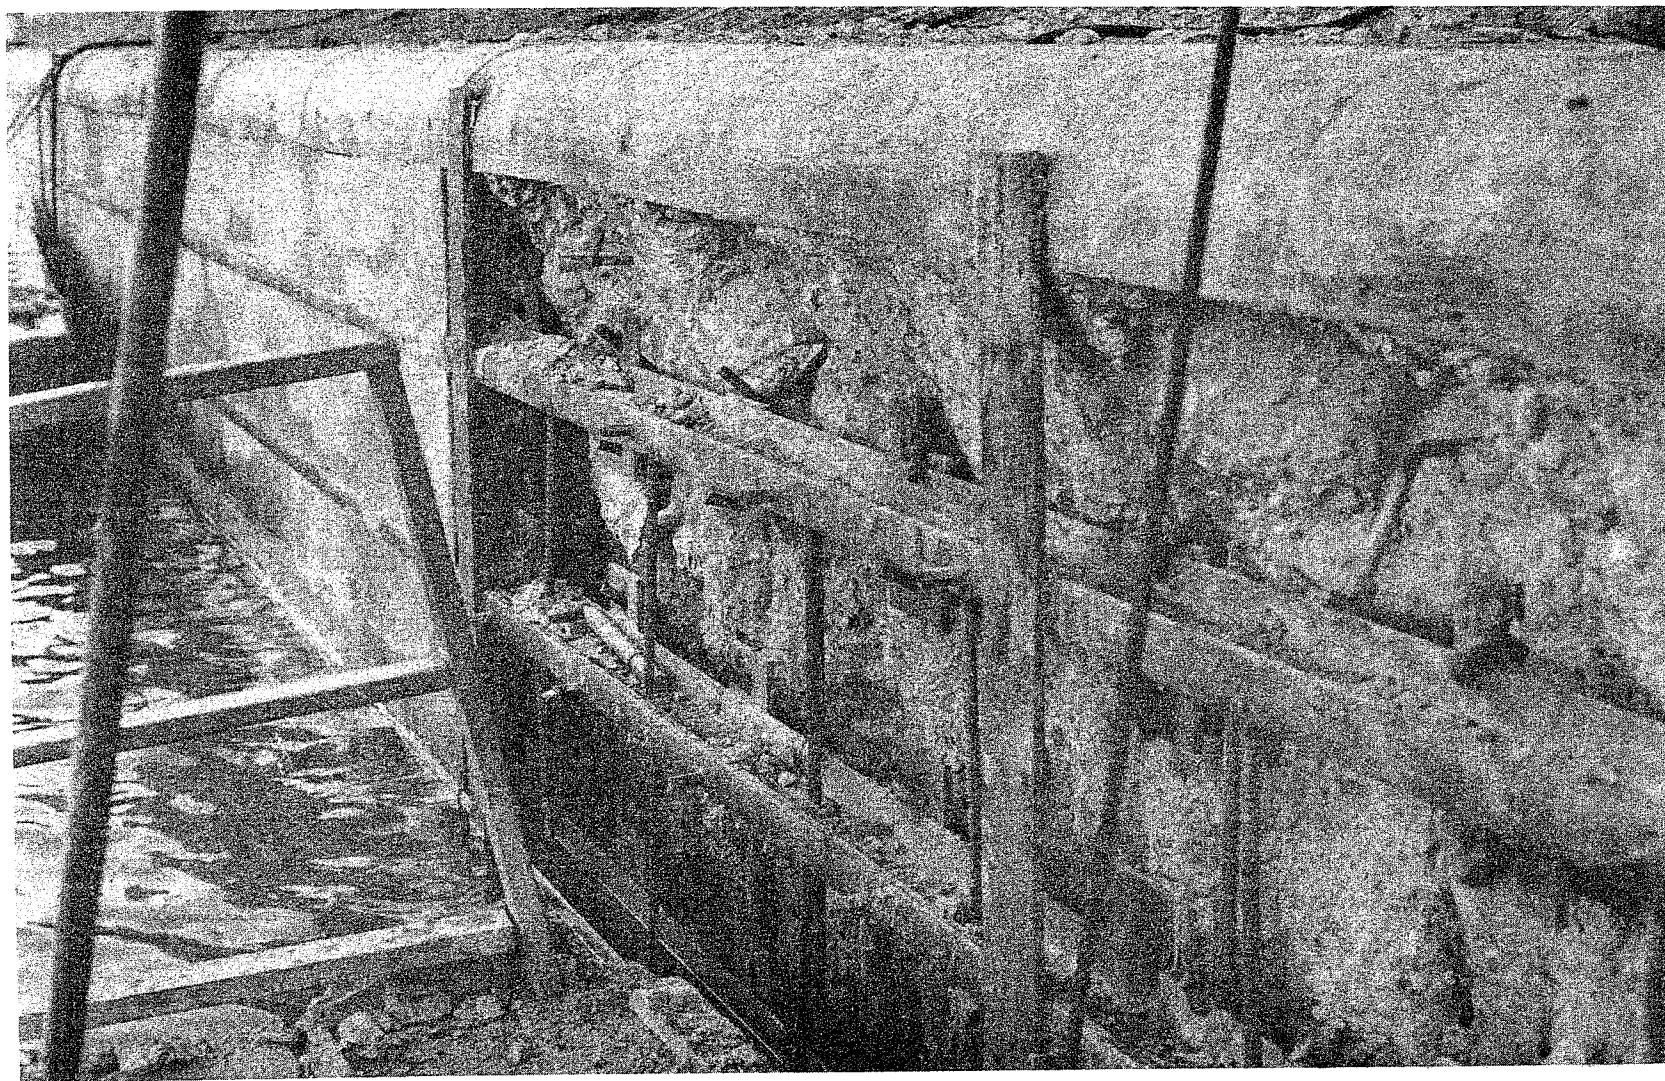
Figure 50. Upper guide wall repairs, December 1976, Lock No. 3, Monongahela River

105. The work was done on one monolith at a time beginning at Station 4+25A. Old concrete was removed from the face of the wall by jackhammer where necessary to provide a minimum depth of 12 in. for the new concrete. The repair extended from the top of the wall to the waterline (approximately 6 ft). After the concrete was removed, No. 7 dowels were grouted into the wall on 2-ft centers. Initially Sikadur Hi-Mod Gel, as manufactured by the Sika Corporation, was used to anchor the dowels. The gel proved difficult to inject into the holes, so a sand-cement grout was used instead. Wire mesh, 6 by 6, No. 6, was attached to the dowels. Three 35-ft sections of used 90-lb railroad rail were positioned in the wall, so the rail would extend 1/2 in. past the face of the wall. The rails were spaced 1 ft 8 in. apart vertically to act as wall armor (Figure 50). When the reinforcing and rails were in place, forms were erected for the wall face and concrete was placed. Ready-mix concrete with Type II cement was used. By mid-December, the work had been completed to Station 5+87A. High water and adverse weather conditions made it impractical to continue. The rest of the upper guide wall was repaired by the

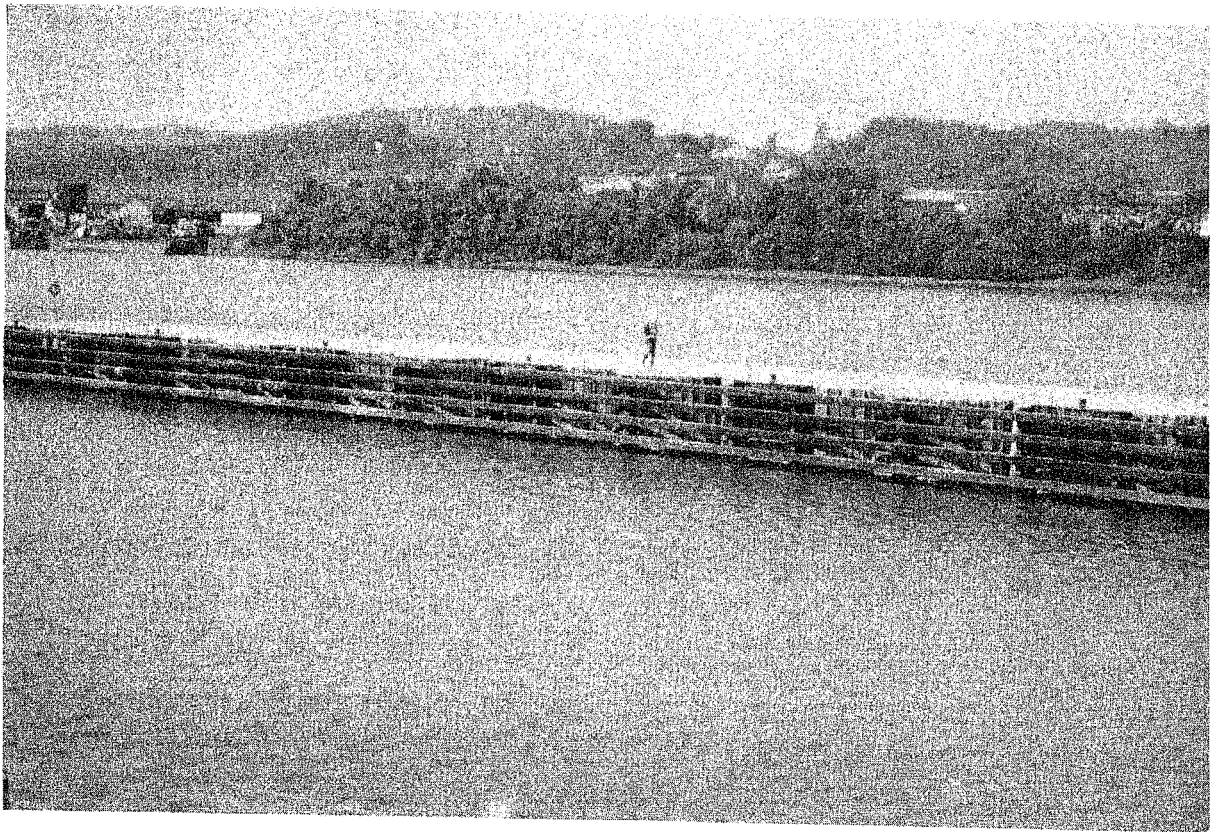
Figure 51. Upper guard wall extension, October 1977,  
Lock No. 3, Monongahela River

total contract price of \$520,448. The contractor, Crain Brothers, Incorporated, had a lot of prior experience with cell construction and thus was instrumental in successfully completing the work on schedule. There was no settlement in any of the concrete caps, and the caps were free of cracks. The uppermost cell, which is concrete-filled, had a few hairline cracks in the top surface.

112. A steel fender system, consisting of four rows of TS 10 by 10 tubing filled with concrete, was constructed on the landside of the cells. The upper guard wall extension (Figure 51) was completed in September 1977 at a

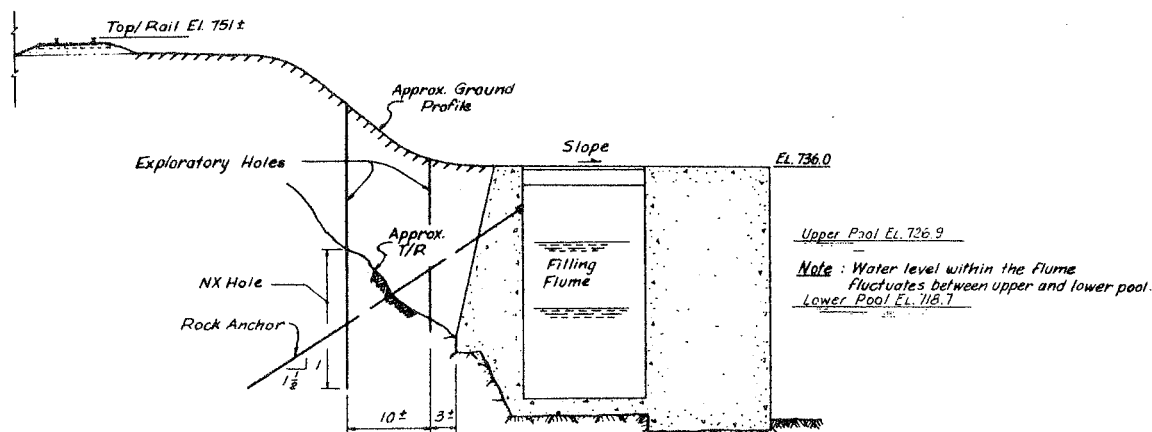
slabs and beams. The beams were crushed at both ends, and the deteriorated concrete in the beams exposed the reinforcing steel. There was evidence that some movement of the flume wall had occurred. With continued deterioration of the slab and beams, failure of the wall would have occurred.

Figure 52. Section through land chamber filling flume looking upstream, Lock No. 3, Monongahela River

114. It was determined that the best method of stabilizing the flume wall was with rock anchors (Figure 52). The original design called for the

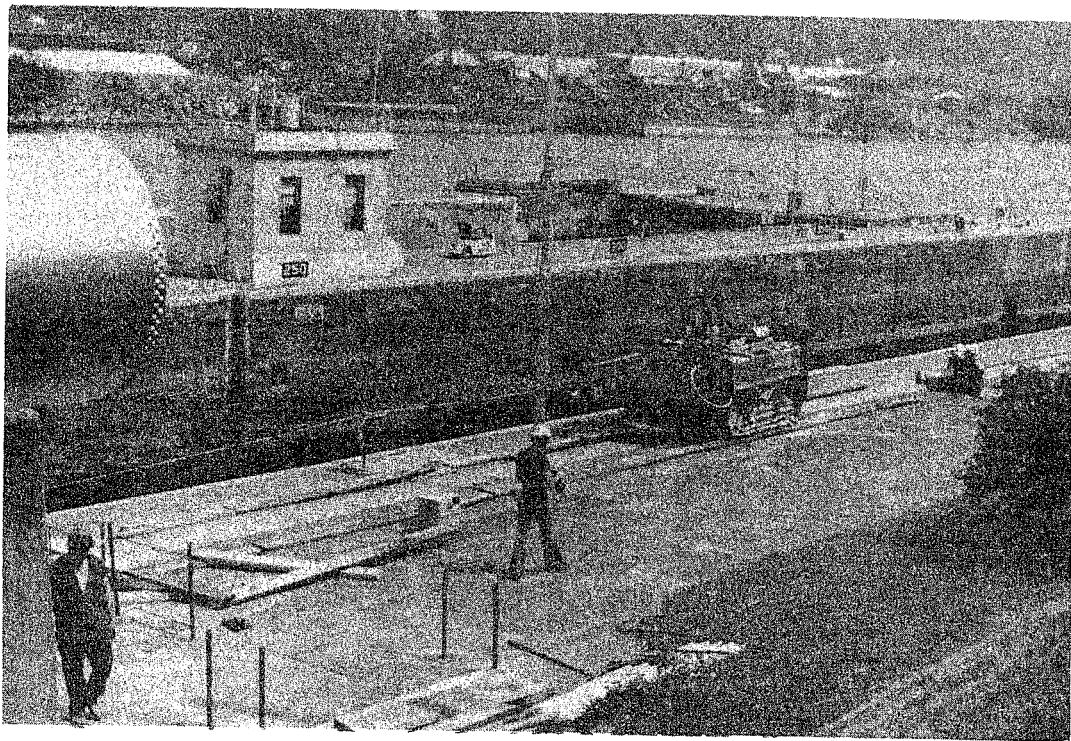
Figure 53. Crawler-mounted drill rig used for anchor installation, Lock No. 3, Monongahela River

116. Anchor boreholes, 4-1/2 in. in diameter, were drilled on a 1.5V on 1H slope through the concrete and the overburden. A standard 4-in.-diam Schedule 40 pipe was placed through the overburden and 1 ft into rock. A 3-1/2-in.-diam hole was then drilled 20 ft into rock. The drilling equipment used by the contractor consisted of a crawler-mounted hydraulic drill rig specially designed and built for anchor installation (Figure 53). Because of the

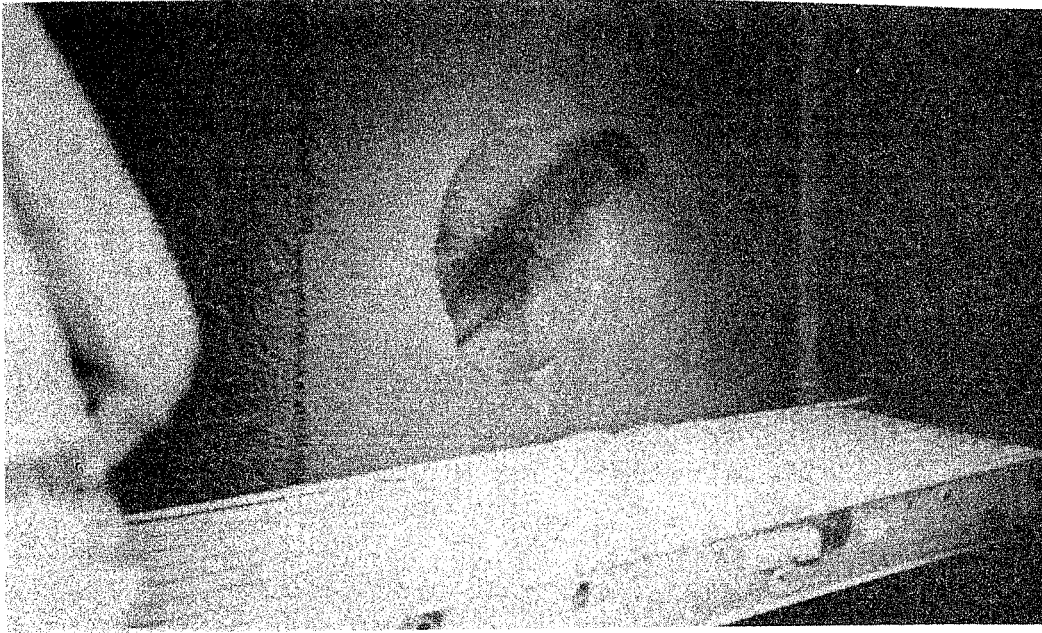
Figure 54. Installation of filling flume anchors,  
Lock No. 3, Monongahela River

because downstream of the operations building the anchor heads are located 5 ft below the top of the filling flume slab (Figure 54). Another difficulty was that high water is fairly common at Lock No. 3, and the contractor had to install scaffolding or work platforms inside the flume that could be easily raised. The contractor had to break an opening in the slab and drill at a 1V on 1.5H slope through the concrete retaining wall and the overburden material while advancing a 4-in. diam casing and, finally, into the rock for a depth of at least 20 ft. The slope and the vertical location of the anchors were optimized by many trials using various slopes and locations. The controlling criterion for the design of the anchors was to keep the resisting-to-overturning moment ratio around 1.3. This value is not usually computed for new structures. In the Pittsburgh District when investigating stability for existing structures undergoing rehabilitation, it is found that this ratio gives a better perspective of possible overturning failure, more than just the percent active base criteria (Krysa 1982).

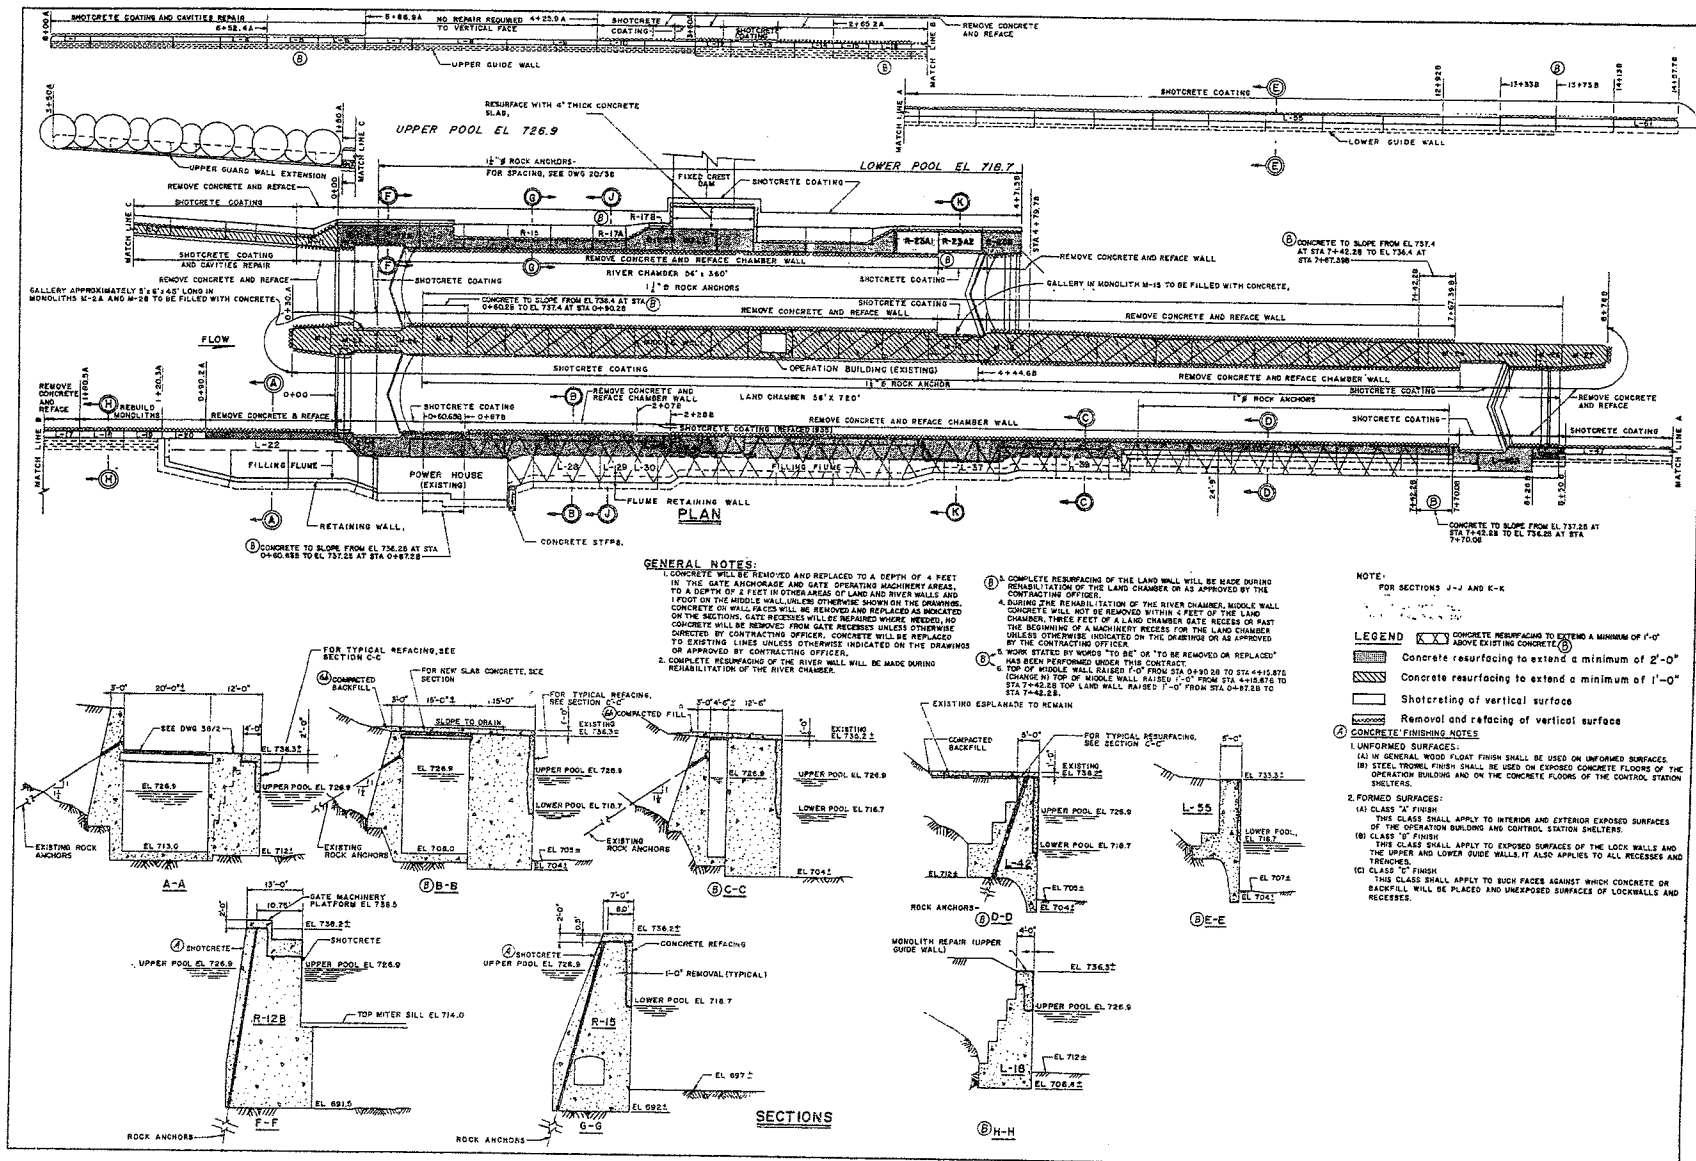
Figure 55. Refacing, resurfacing, and anchoring details, Lock No. 3, Monongahela River

128. A system of rock anchors was designed (Figure 55) to upgrade the stability of the lock walls to the reduced requirements. The original design called for one hundred eleven 1-1/4-in.-diam anchors in the upper guide wall, sixty-two 1-in.-diam anchors in the lower guide wall, twenty-three 1-in.-diam anchors in the land wall, one hundred twenty-eight 1-1/4-in.-diam anchors in the middle wall, and seventy-six 1-1/4-in.-diam anchors in the river wall. The anchors on the land and guide walls were to be locked-off at 20 percent of ultimate, 25 kips for the 1-in. bars, and 40 kips for the 1-1/4-in. bars. The anchors on the middle and river walls were to be locked off at 60 percent of ultimate, 112.5 kips.

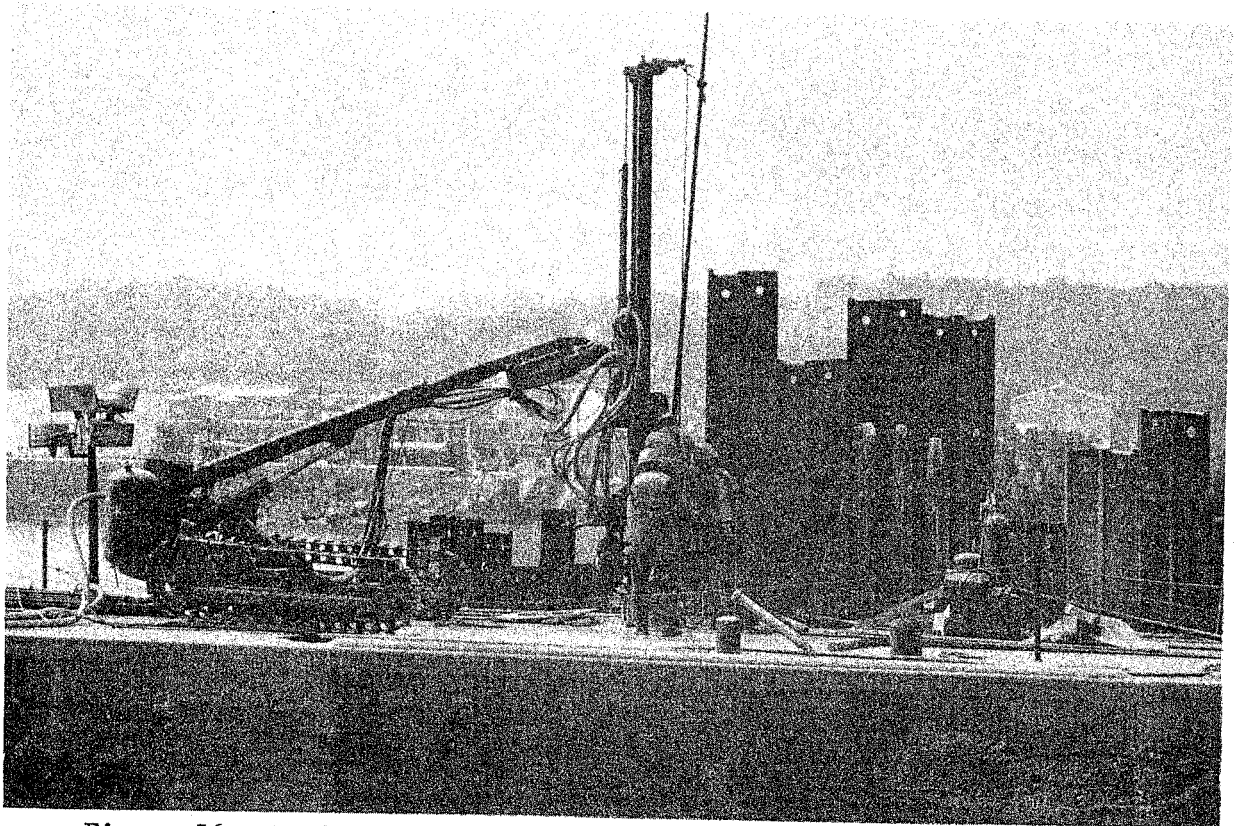
133. Shortly after beginning work on the middle wall anchors, ECI complained that the holes were caving and the anchor rods could not be installed. There were 15 middle wall anchors on the prime contractor's critical path. ECI claimed that increased progress could be achieved by pregrouting. In the interest of expediting the overall project, the Corps agreed to allow ECI to pregrout the first 15 holes, but stipulated an alternative solution should be found. The 15 anchors were installed (Figure 56), but with no improvement in the rate of work. The contractor continued to have drilling problems. At a meeting on 11 October 1978, the Corps directed ECI to install a 3-in.-diam casing in the 4-1/2-in.-diam hole prior to drilling the 2-1/4-in.-diam hole. The Corps had concluded that the material in the hole that the contractor claimed was from caving was actually the drill cuttings. The change in hole diameter from 2-1/4 to 4-1/2 in. was causing a pressure drop which allowed the cuttings to fall back into the hole. The drilling was being impaired by the cuttings. The 3-in. casing improved this condition, and there were fewer

Figure 56. Rock anchor installation, middle wall, September 1978,  
Lock No. 3, Monongahela River

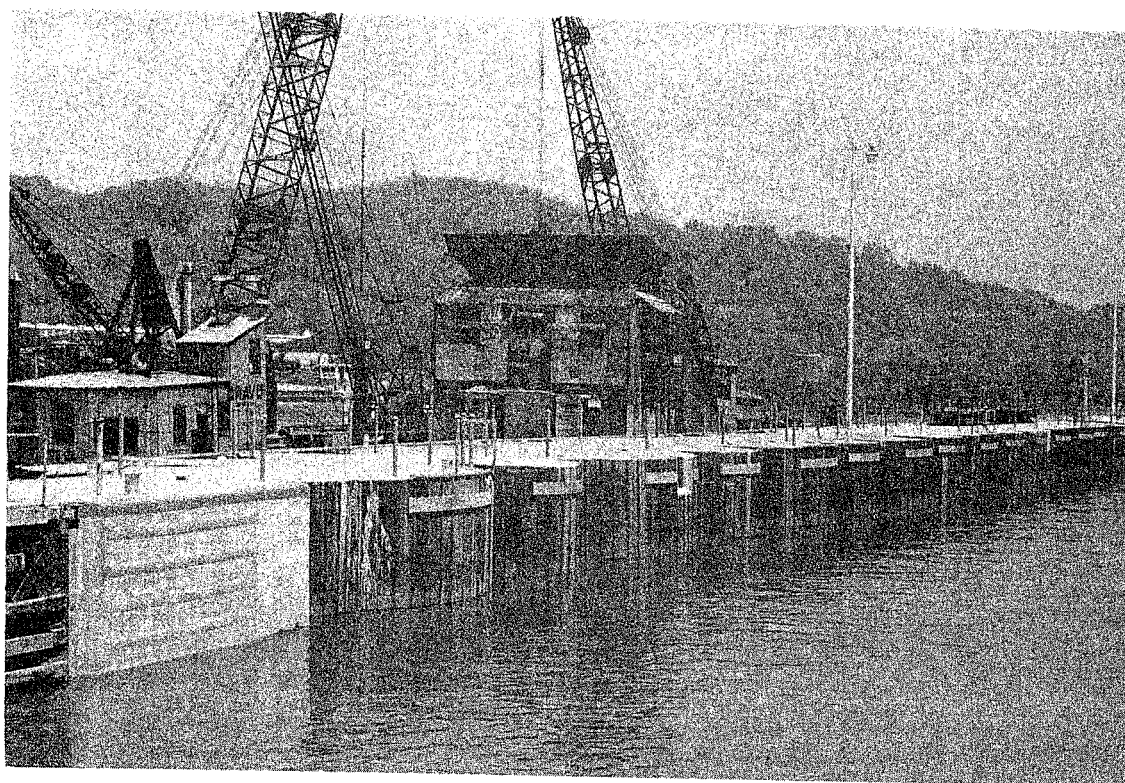
Figure 63. Completed river wall extension, May 1980,  
Lock No. 3, Monongahela River

when the concrete caps on most of the cells and arcs settled to as much as 6 in. on the riverside. A diving inspection was conducted to determine whether cell fill was being lost because of parted interlocks or erosion below piling. The divers found neither condition, and it was concluded that the settlement was caused by fill compaction and would cease.

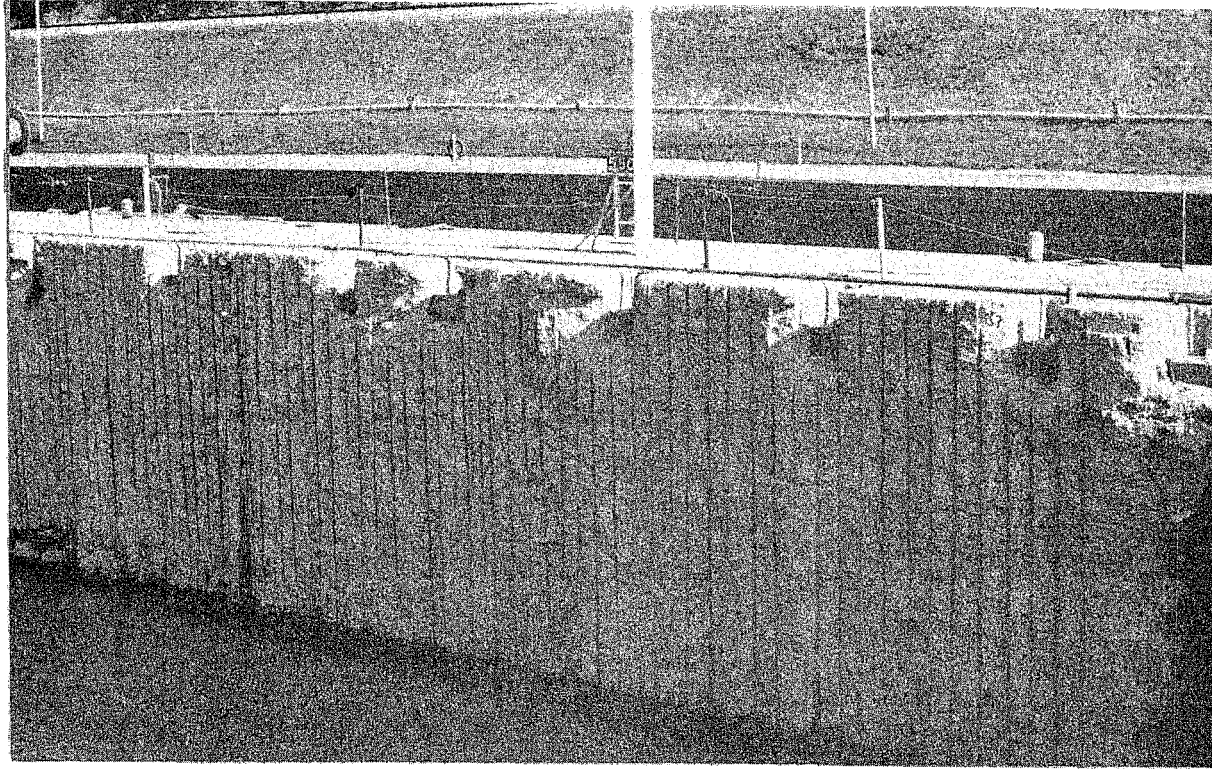
Figure 68. River face of middle wall after blasting, October 1978, Lock No. 3, Monongahela River

155. After the existing concrete was removed from the face of the walls (Figure 68), 1-1/2-in. holes inclined 10 deg below horizontal were drilled on 2-ft centers for No. 6 hook dowels (Figure 69). The dowels were grouted in place with polyester resin grout (Celtite) cartridges. A cartridge was inserted into each hole, and the dowel was installed and spun with an air drill.

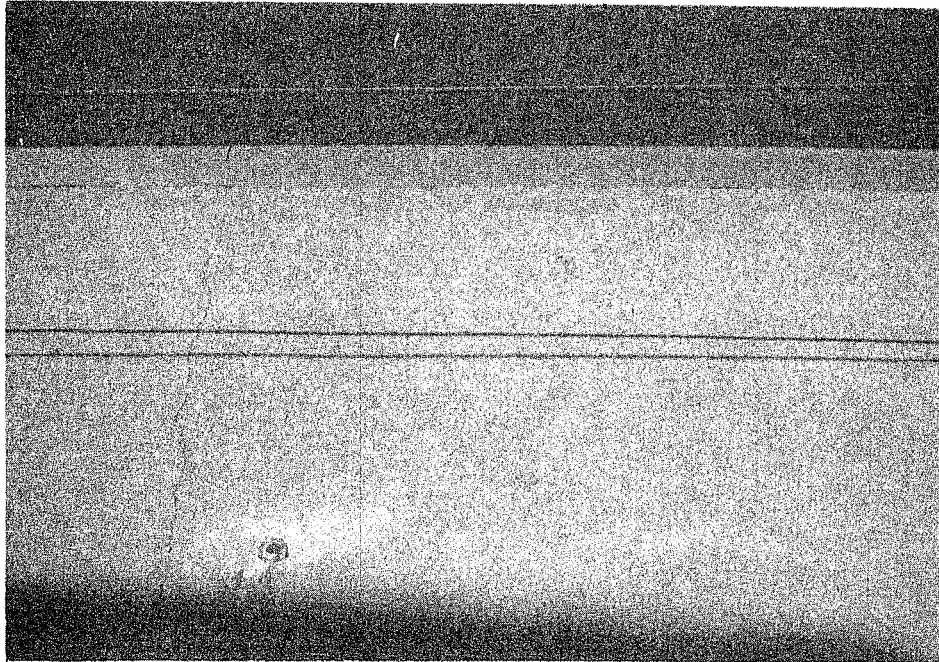
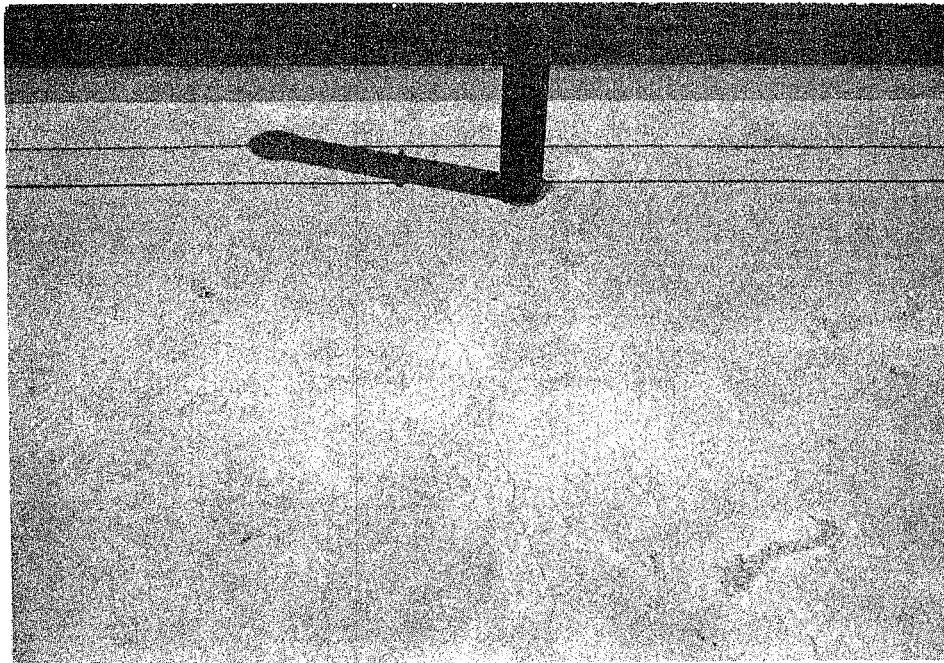
170. In June 1982, isolated cracks were observed in the top surfaces of the lock walls (Figure 75). Most of the cracks are perpendicular to the face of the lock chamber. Although a few cracks were located on approximately 5-ft centers, the regularity noted at other projects was not observed. Rather, the cracks tend to start and terminate at reentrant angles and at joints in the corner protection armor. The thin polymer mortar overlay was debonded and buckled in several places (Figure 76). Failure of the shotcrete overlay appeared to be progressing (Figure 77).

Figure 75. Typical cracks in tops of lock walls, June 1982,  
Lock No. 3, Monongahela River

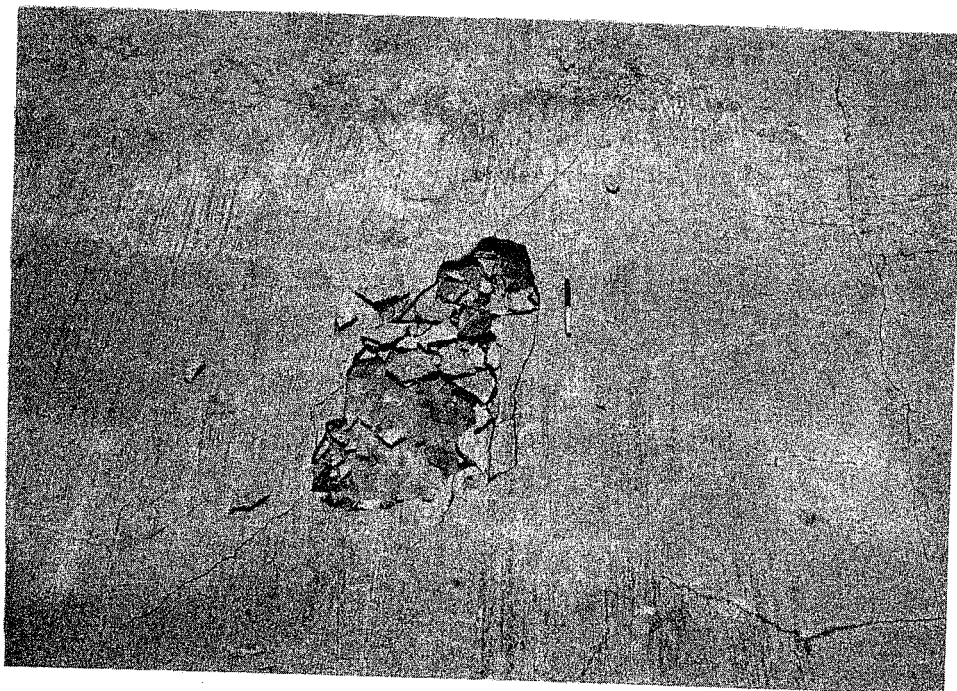
Figure 76. Polymer mortar overlay failure, June 1982,  
Lock No. 3, Monongahela River

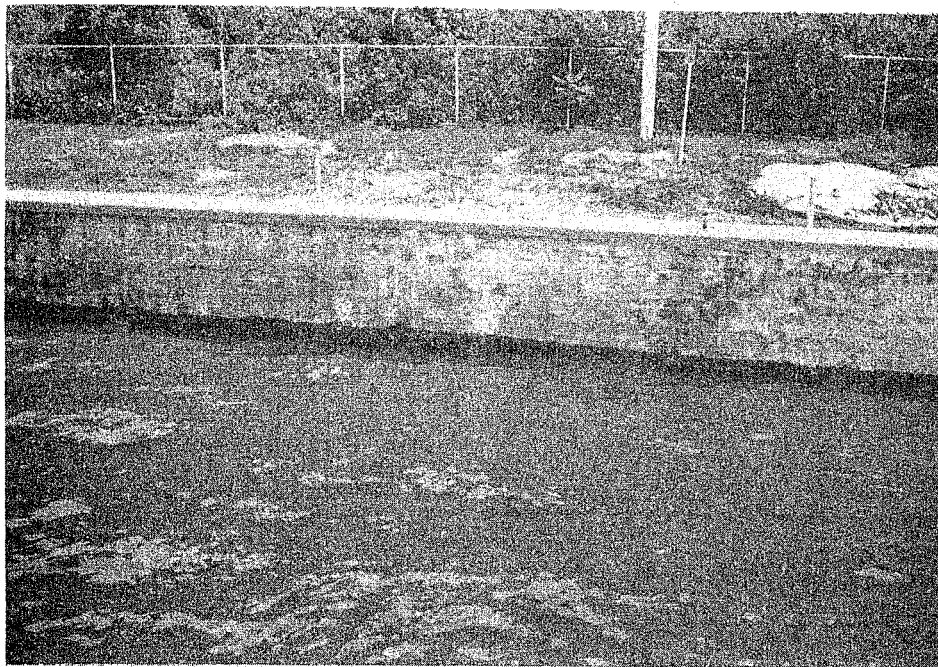
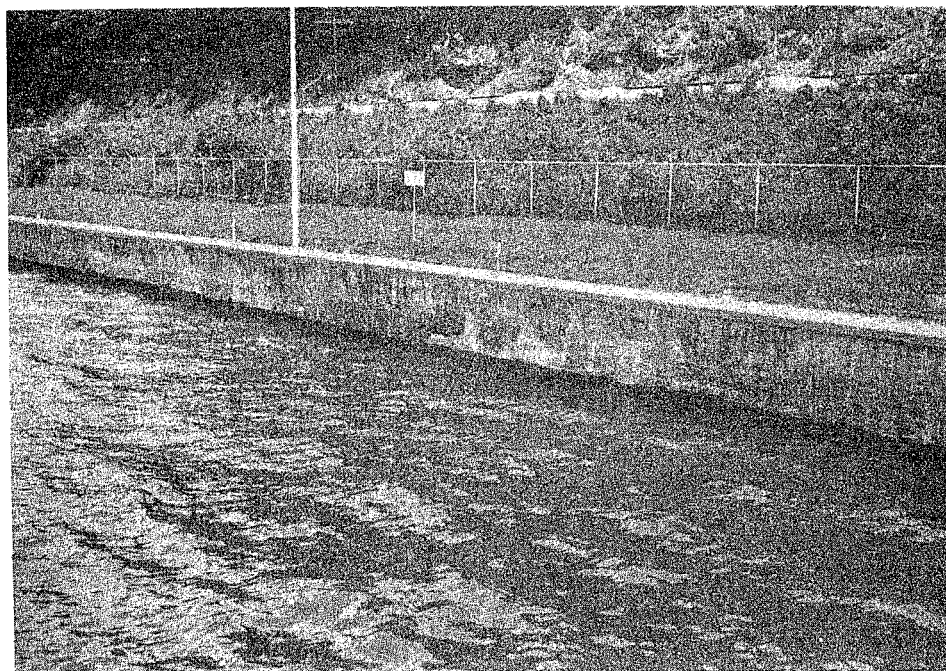
Figure 77. Typical spalling and abrasion of the shotcrete resurfacing on the lower guide wall, June 1982, Lock No. 3, Monongahela River

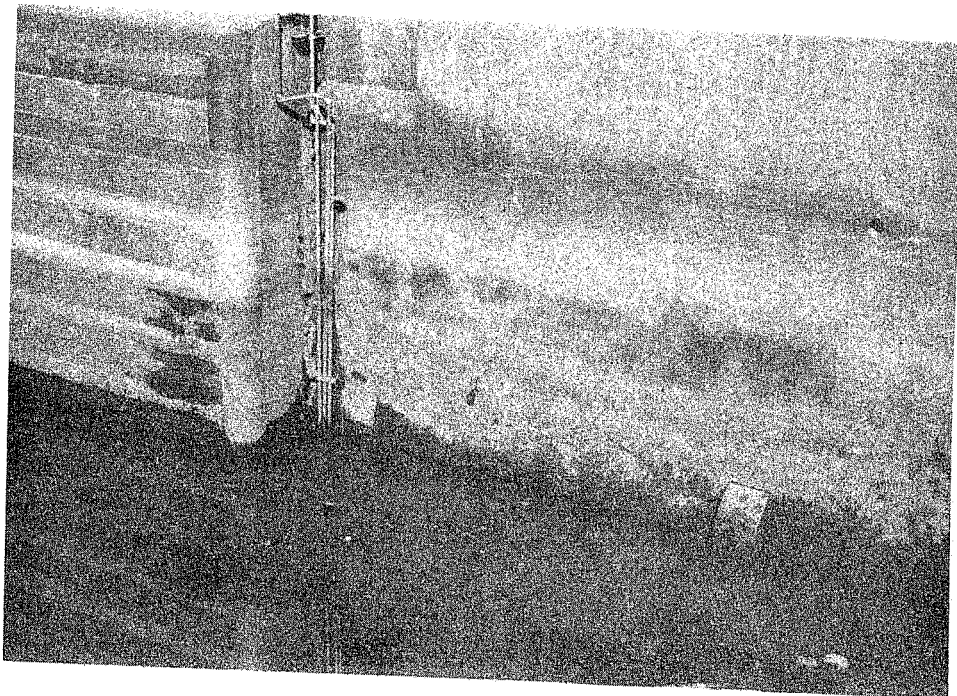
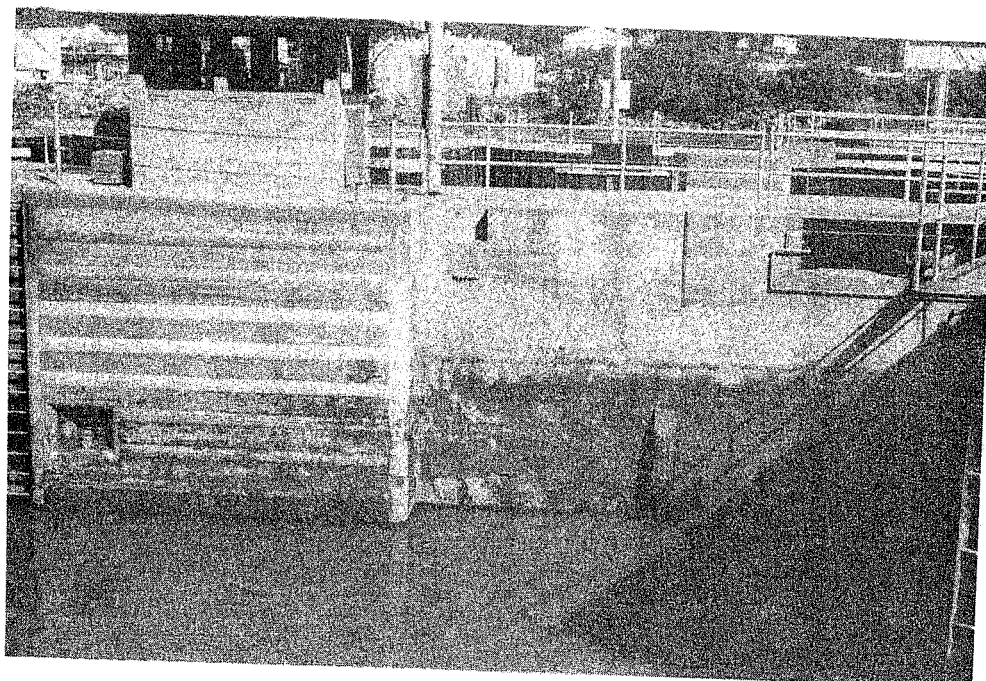
171. In July 1985, additional failures of the shotcrete repairs were reported (Figure 78). Cracks in the top of the lock walls had been caulked with a material manufactured by Thoro System Products. The caulking was done meticulously by project personnel and is not unattractive (Figure 79).

Figure 78. Spalling of shotcrete overlay in gate recess,  
July 1985, Lock No 3, Monongahela River

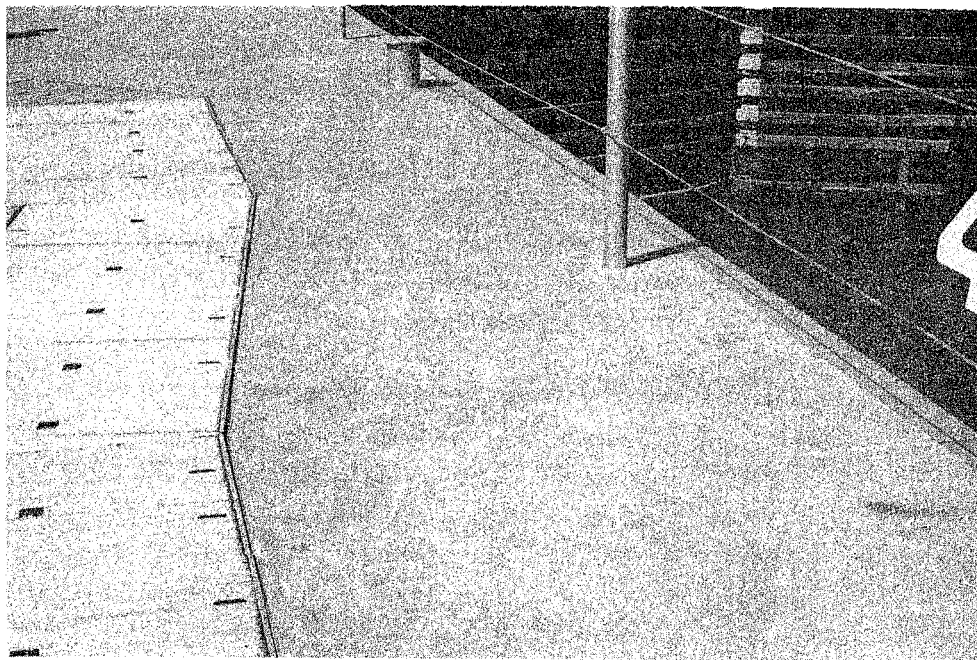
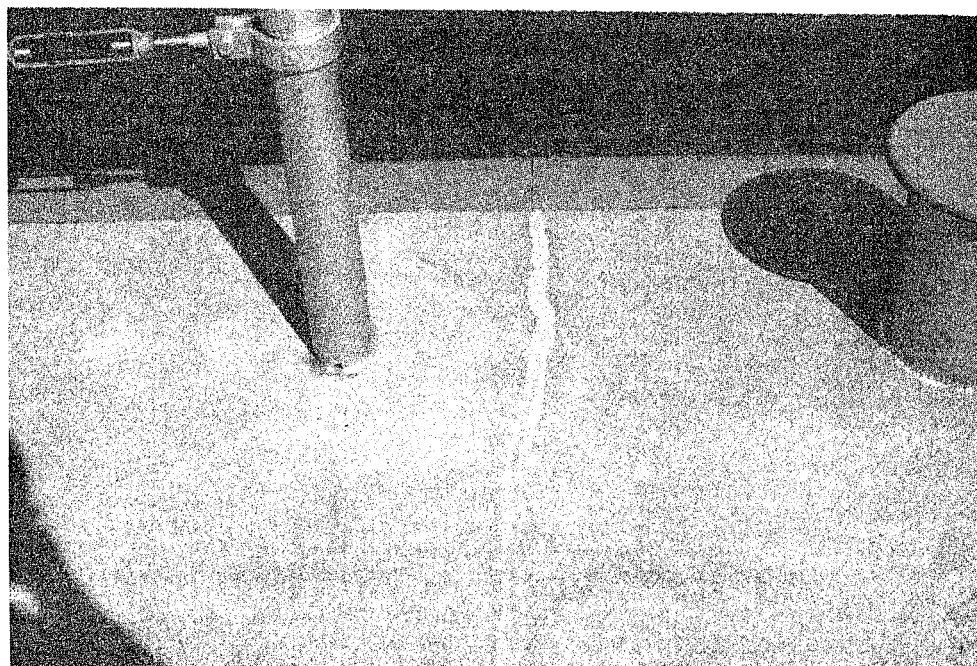
Figure 79. Caulked cracks in top of middle wall, July 1985,  
Lock No. 3, Monongahela River
